**On-The-Ground Improvement Projects
for the Upper Gallinas River and Porvenir Creek Phase III**

FINAL REPORT

HERMIT'S PEAK
WATERSHED ALLIANCE

June 30, 2022

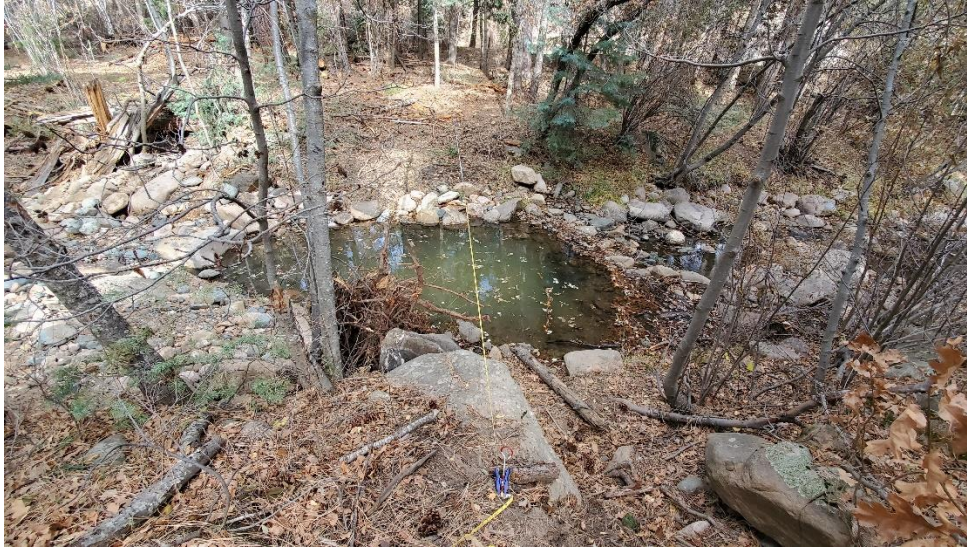
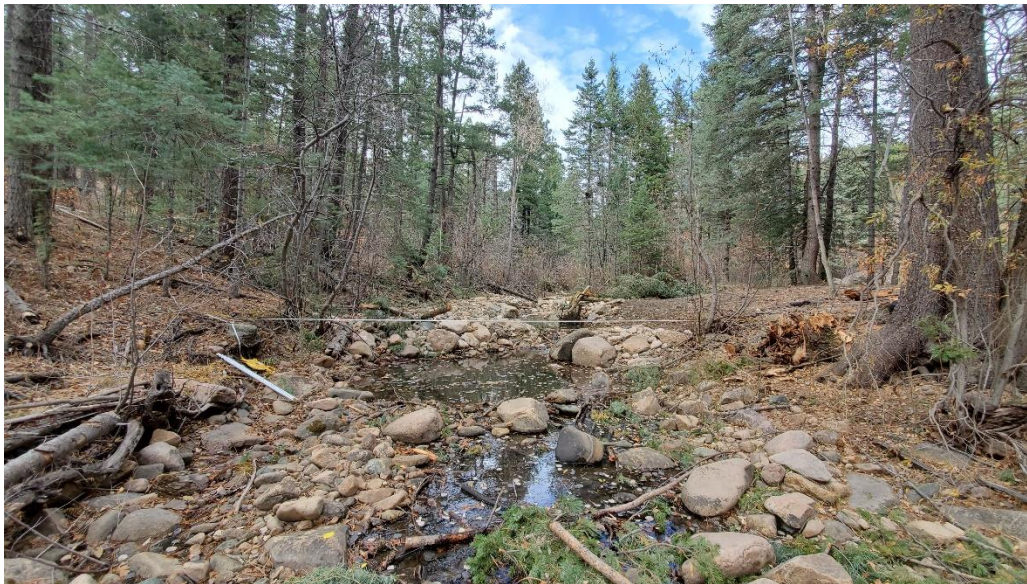
El Porvenir Christian Camp In-stream Restoration

Post treatment of Porvenir Creek instream restoration project looking upstream. Pools were deepened and streambanks anchored.

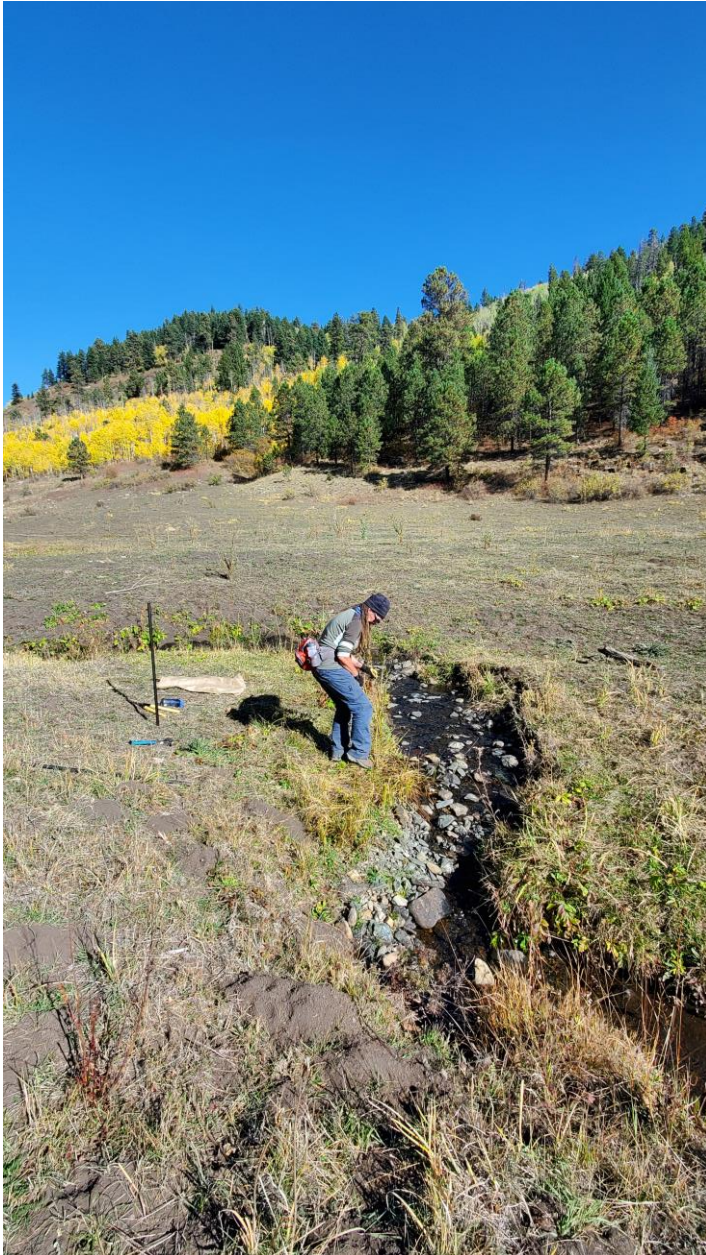
Volunteer planting willows along Beaver Creek.

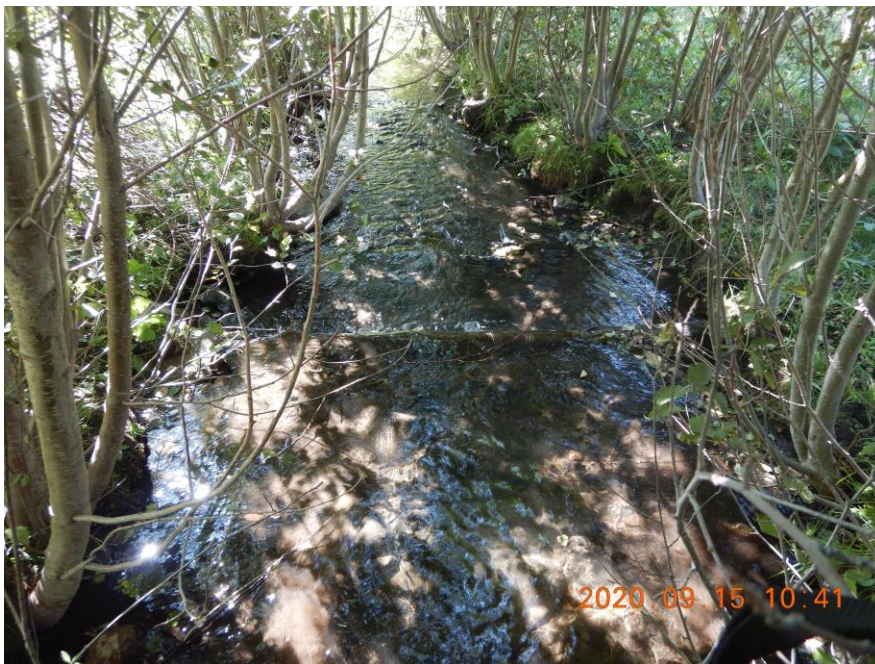
Man-made log dam repairs - LD 12 looking downstream before log notching.

Eleven log dam repairs were done by CM ArborCare during July to October of 2020. They were permitted by US ACE 404 permit SPA-2019-00235-ABQ (Beaver Creek Restoration Project) dated Sept. 16, 2019. Repairs were with a thalweg notch alone or in combination with repairing the stream widening that occurred when stream flow moved around the ends of the logs with on-site rocks to force water flow over the center of the log. All log dams needing repaired were done.

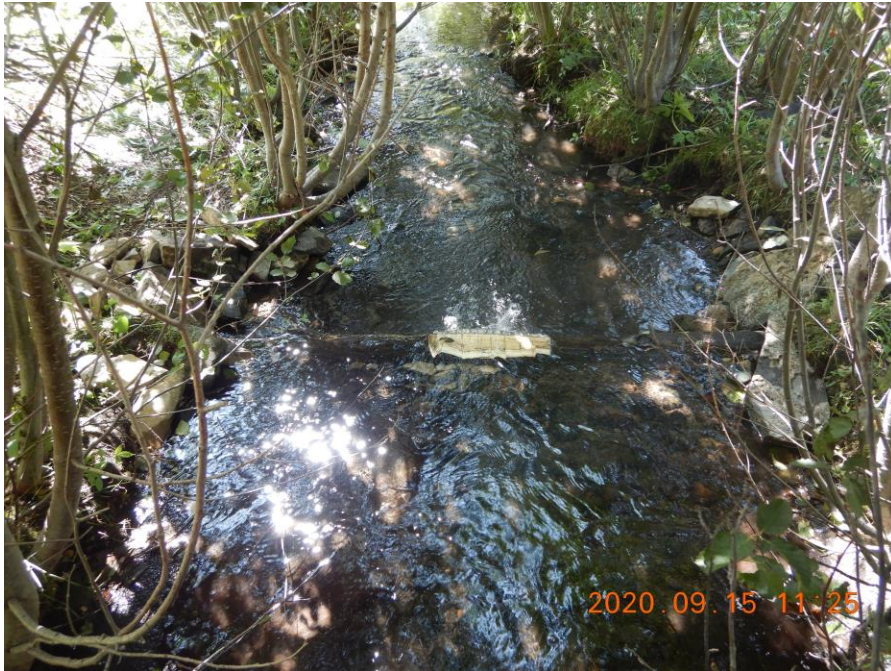
Man-made log dam repairs - LD 12 looking downstream after log notching.

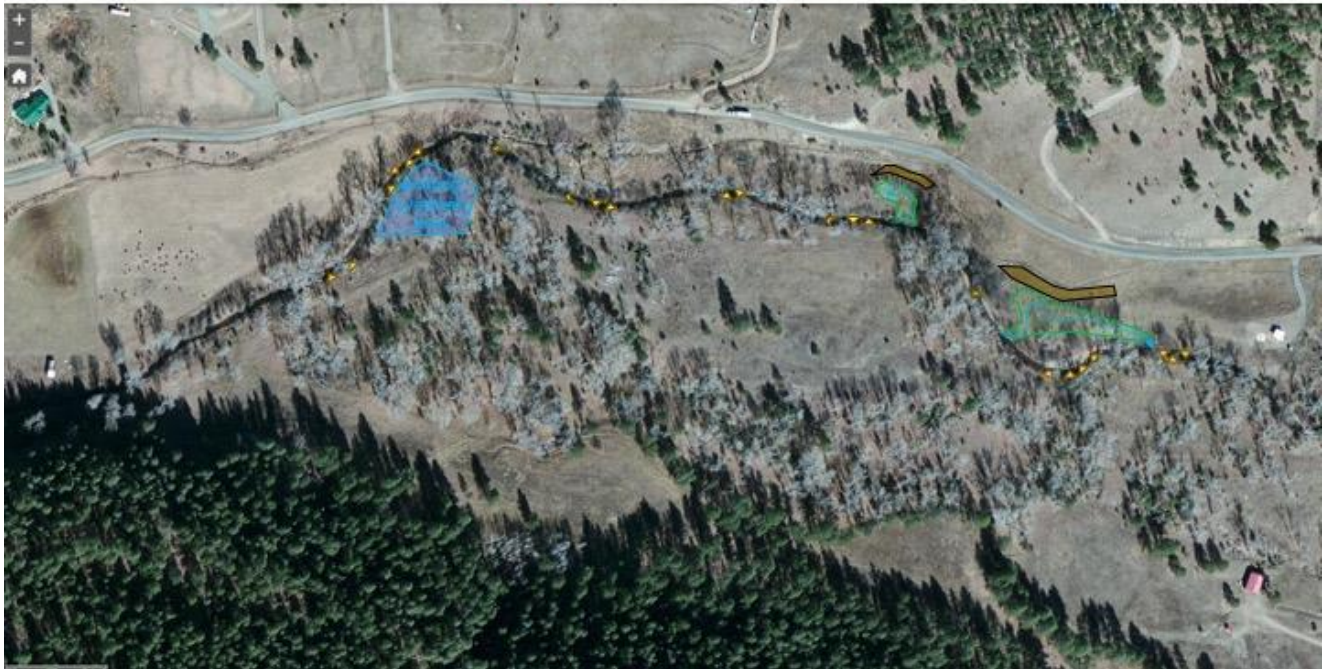
Gallinas River: Gomez/Galligan Restoration Project

Excavation overburden fill area
- * All treatment locations are approximate
