Wolf Creek Stream and Riparian Restoration – New Mexico's Front Range Wetland Complex Protection and Restoration Project I

Final Report

Submitted to NM Land Conservancy
by Hermit's Peak Watershed Alliance

July 12, 2021

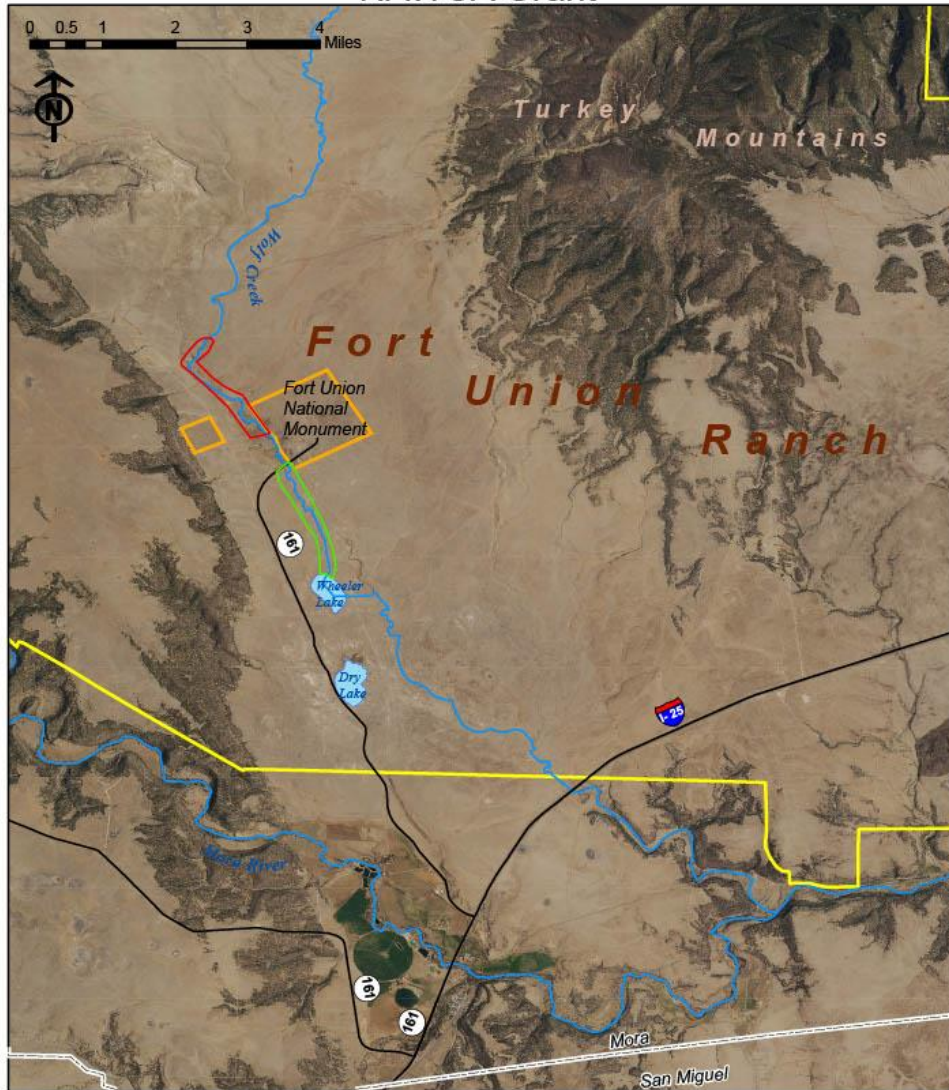
Map 1. Wolf Creek Stream and Riparian Restoration Project as part of the New Mexico's Front Range Wetland Complex Protection and Restoration Project I funded by a National Wetlands Conservation Act (NAWCA) grant.

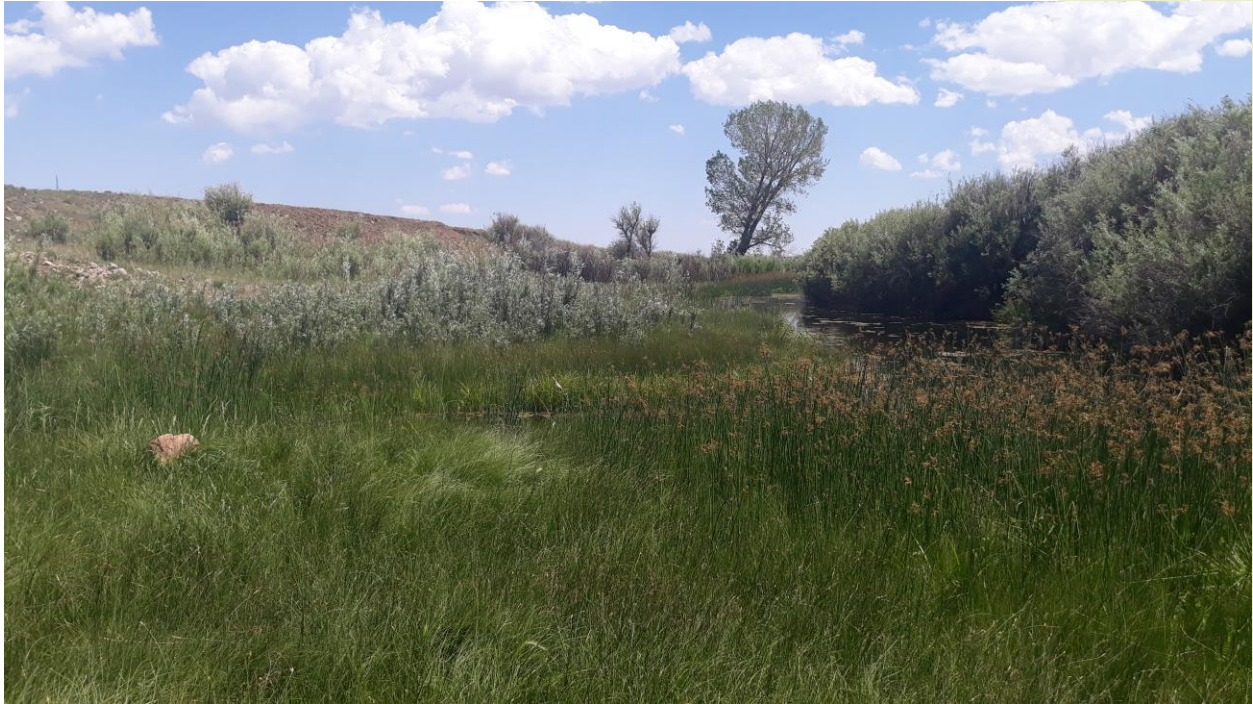
Figure 1. Picture of a 2017 restored reach of Wolf Creek, with ORD structures, part of the PLJV project.

Instream restoration work on Wolf Creek began in 2017 with two grants. One from the NM Environment Department section 319(h) of the Clean Water Act titled *On-the-Ground Improvement Projects for the Mora River - Upper Canadian Plateau Phase 1A* and one from the Playa Lakes Joint Venture (PLJV). Two miles of the stream was treated with 39 structures (a copy of the NMED and PLJV project reports are available upon request). This NAWCA funded project continues that work downstream, adding 1.2 miles of restored stream with 24 structures (see Figure 1).

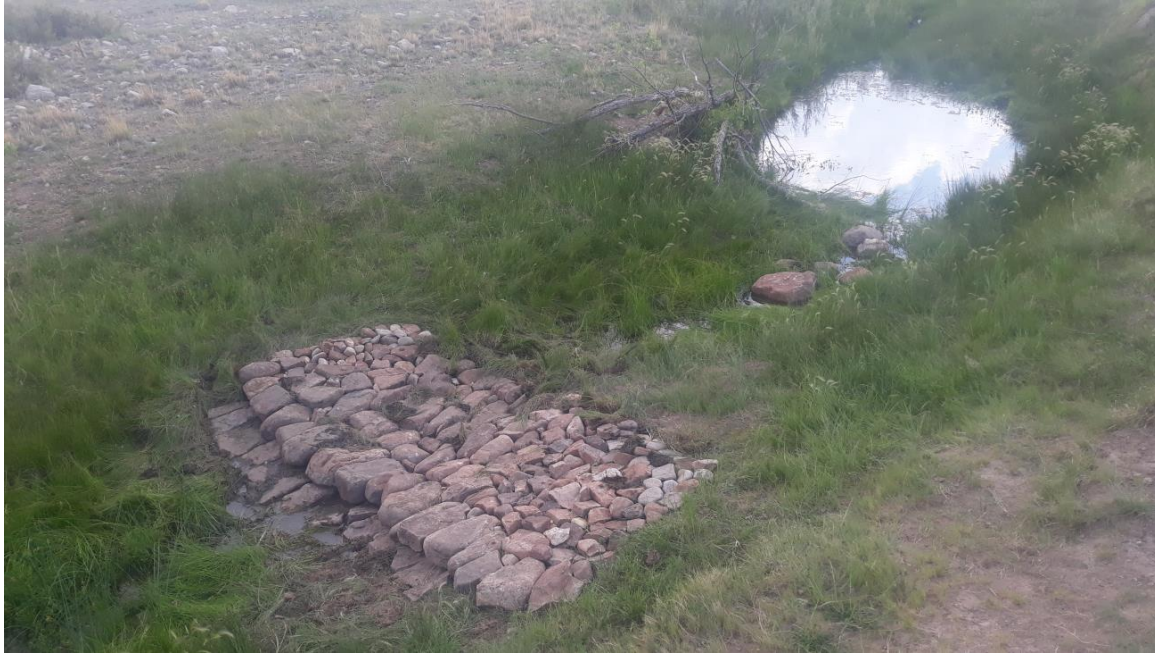
Figure 2. ORD structure and the wetland riparian vegetation surrounding the structure on Wolf Creek.

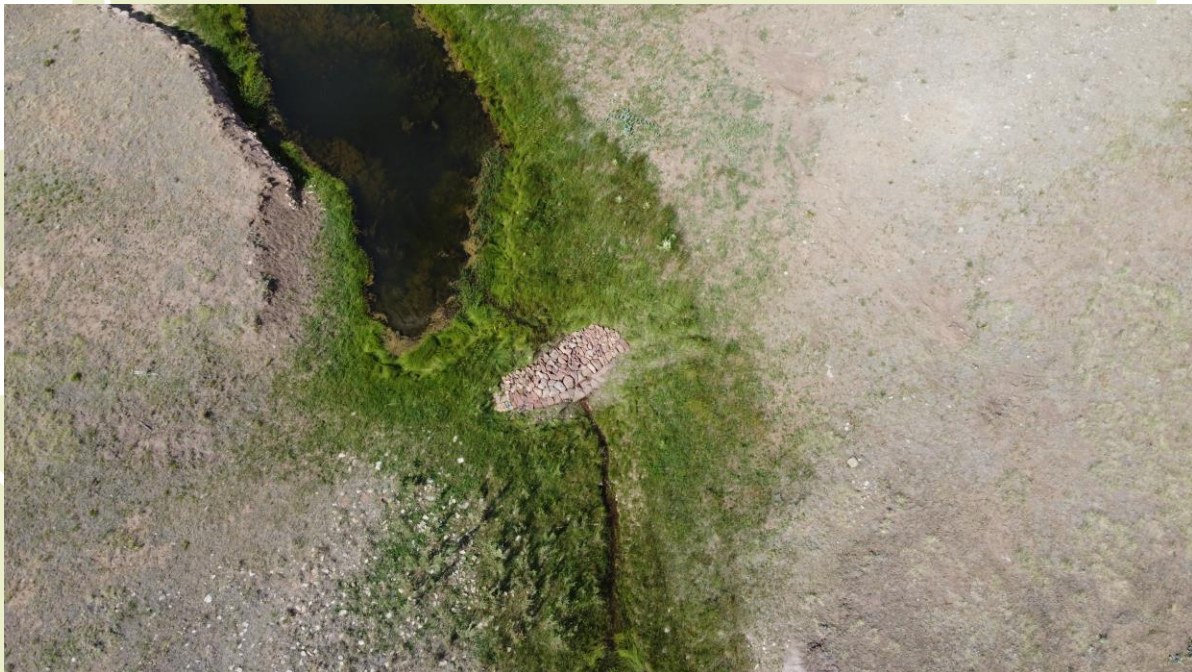
Figure 3. Aerial view of the ORD structure taken by a drone.

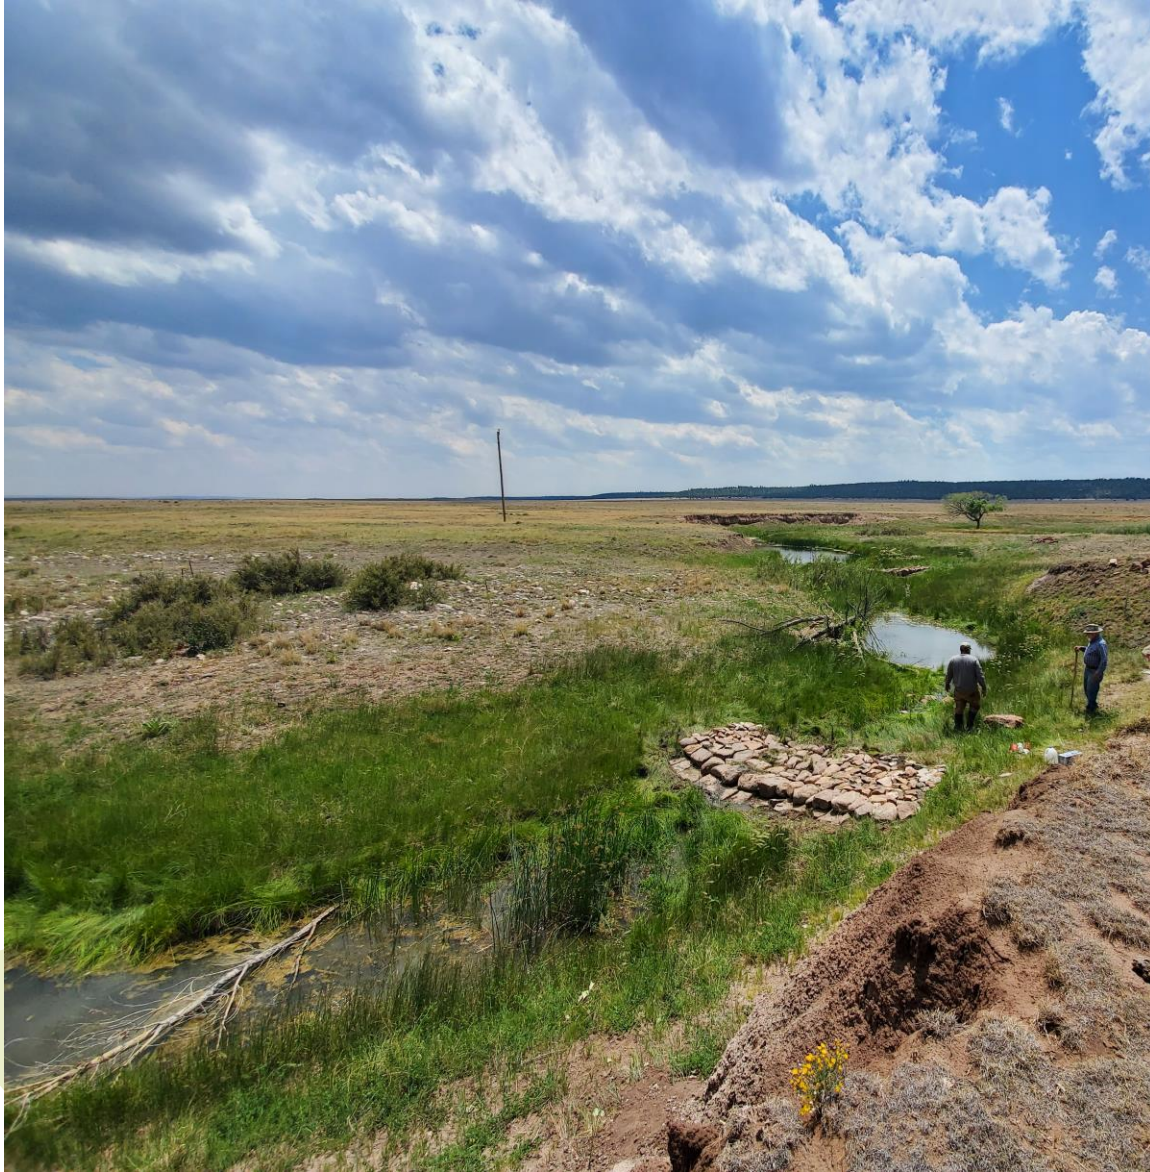
Figure 4. Bill Zeedyk directing the construction of an ORD structure.

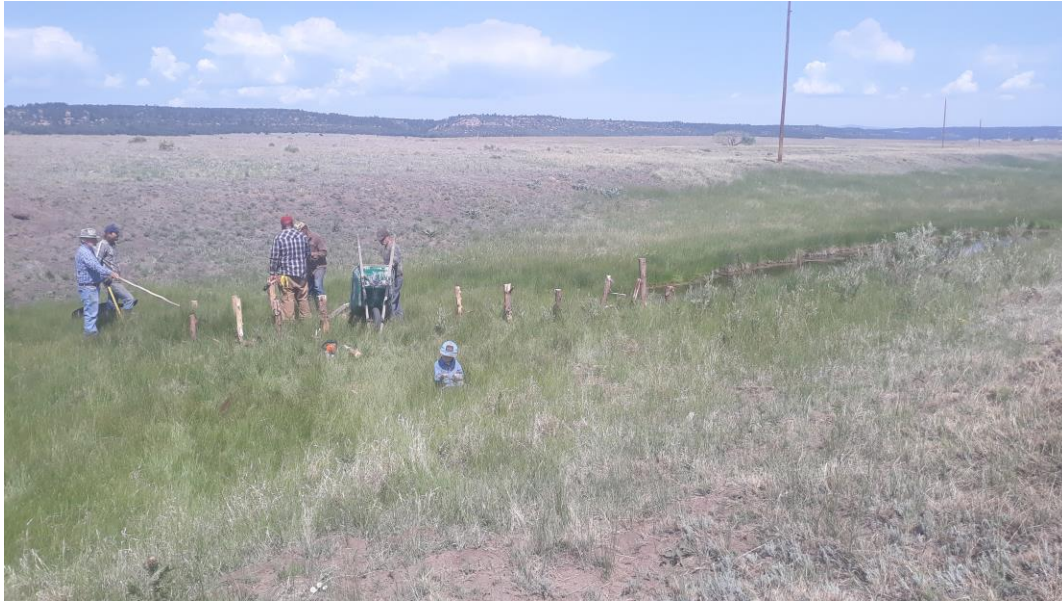
Structures were built with various sizes of rock collected across Fort Union Ranch by ranch staff and with wood juniper poles harvested in forest thinning projects on the ranch.

Figure 5. Bill Zeedyk directing the construction of a juniper pole baffle on Wolf Creek.

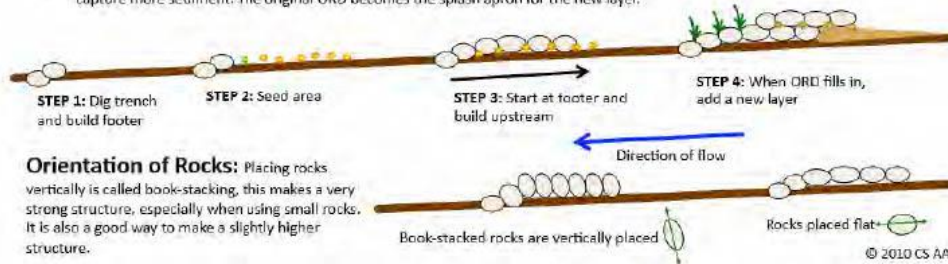
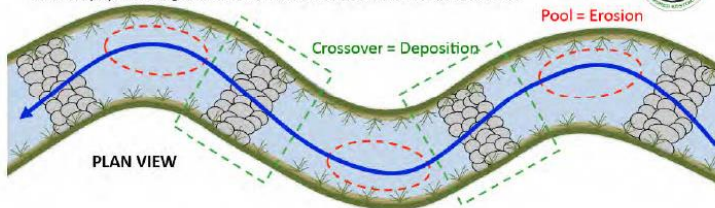
ONE ROCK DAM

A low grade control structure built with a single layer of rock on the bed of the channel. ORDs stabilize the bed of the channel by slowing the flow of water, increasing roughness, recruiting vegetation, capturing sediment, and gradually raising the bed level over time. ORDs are also passive water harvesting structures. The single layer of rock is an effective rock mulch that increases soil moisture, infiltration, and plant growth. Original concept developed by Bill Zeedyk.

1. Select area to build the ORD; dig a shallow footer trench and fill with one or two rows of rock, so that no rock protrudes more than 2 in/5cm above the bed of the channel. This will serve as the splash apron for the ORD.
2. Scatter native grass and wildflower seeds in the area where the ORD is to be built.
3. Start building at the footer and continue upstream, laying down one layer of rock horizontally, as if you were building a rock wall.
4. Once the ORD is completely filled with sediment, another layer can be added to further raise the bed of the channel and capture more sediment. The original ORD becomes the splash apron for the new layer.

1. Always position grade control structures at meander crossovers.

2. Placement at crossovers maintains natural erosion and deposition patterns.

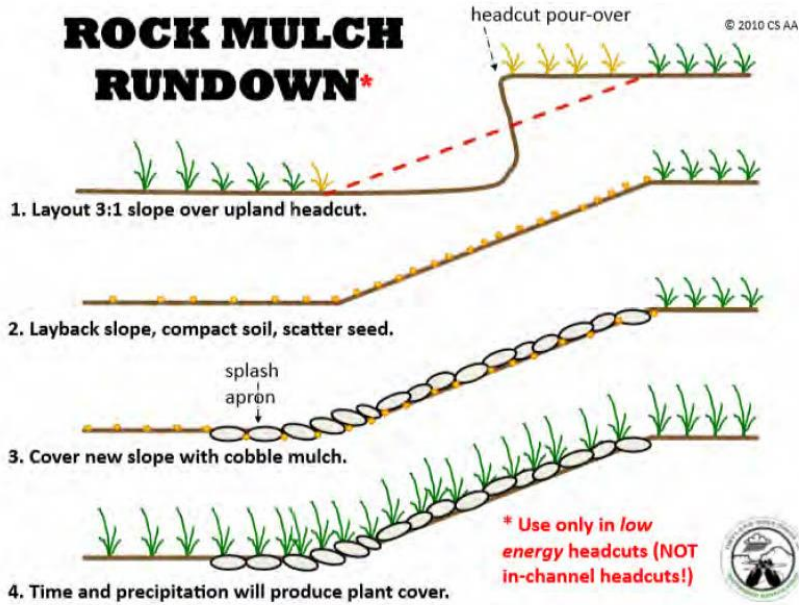
ROCK MULCH RUNDOWN*

A headcut control structure where the face of the headcut has been laid back to a stable angle of repose (minimum of a 3:1 slope), and then covered with a single layer of rock mulch. The mulch serves to slow runoff, increase soil moisture, recruit vegetation, and ultimately prevent the headcut from migrating further up slope. Rock Mulch Rundowns are ONLY to be used on low energy headcuts, like those found in upland rills and gullies with small catchment areas, and where sheetflow collects and enters a channel. Original concept by Craig Sponholtz.

8. Continue to lay rock on the surface of the Rundown until you reach the height of the **headcut pour-over**. No rocks should protrude above this level to allow water to flow freely over the structure. It is very important to avoid gaps in the rock work because gaps cause weak points in the structure. Fill gaps with small gravel if needed. To improve durability, you can use a biodegradable geotextile mesh to line the surface of the Rundown prior to laying rocks.

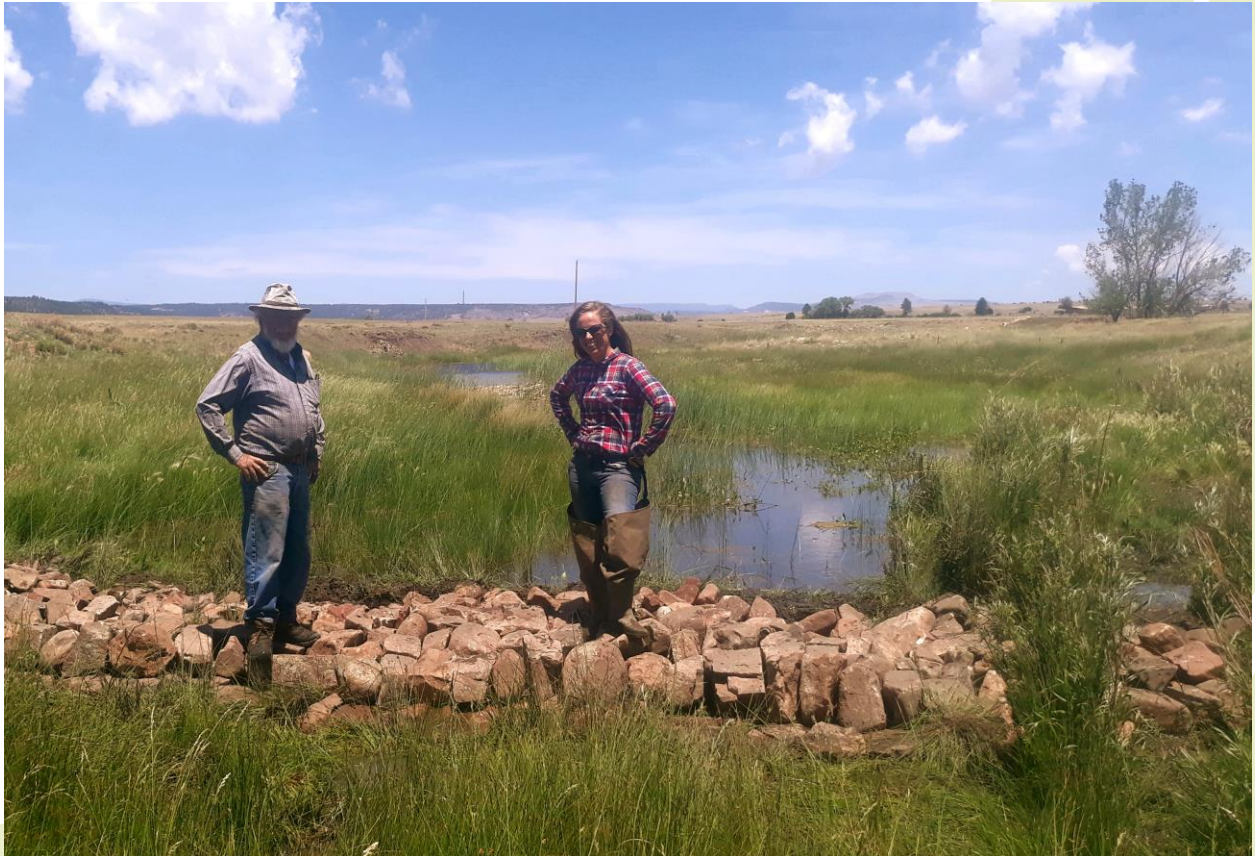
Figure 6. Bill Zeedyk and Amina Sena on the first constructed ORD, as part of an early training workshop.

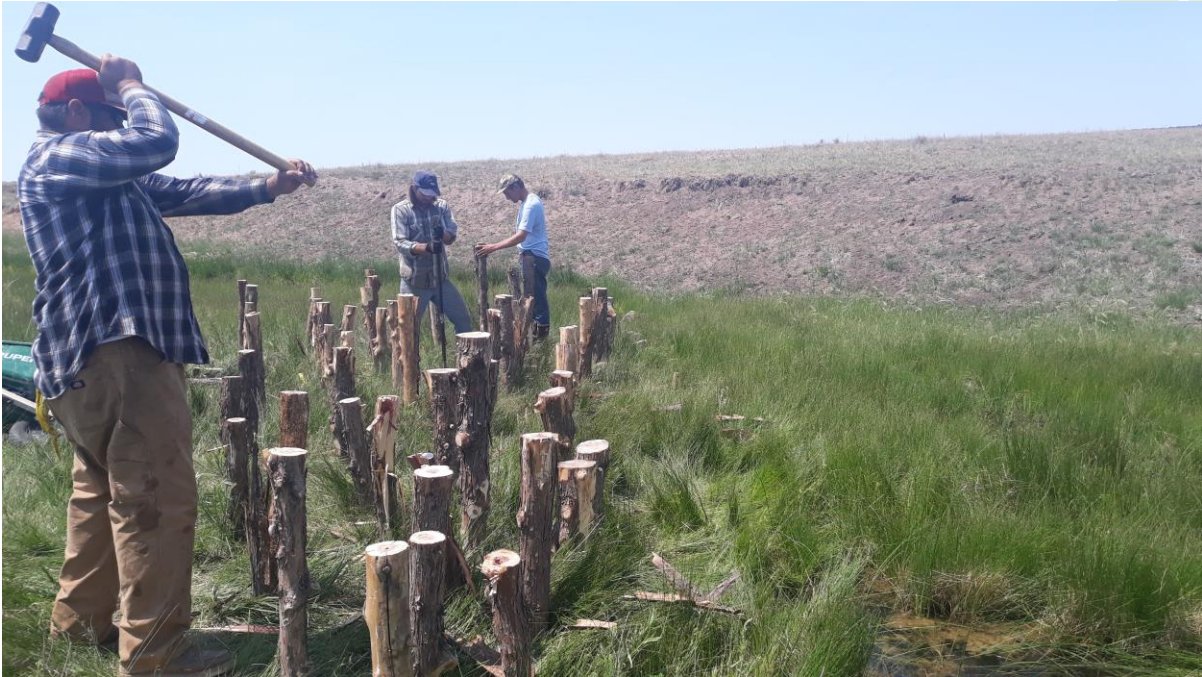
Figure 7. Construction of Juniper wood pole Baffle, built to induce meandering of bankfull flood flows.

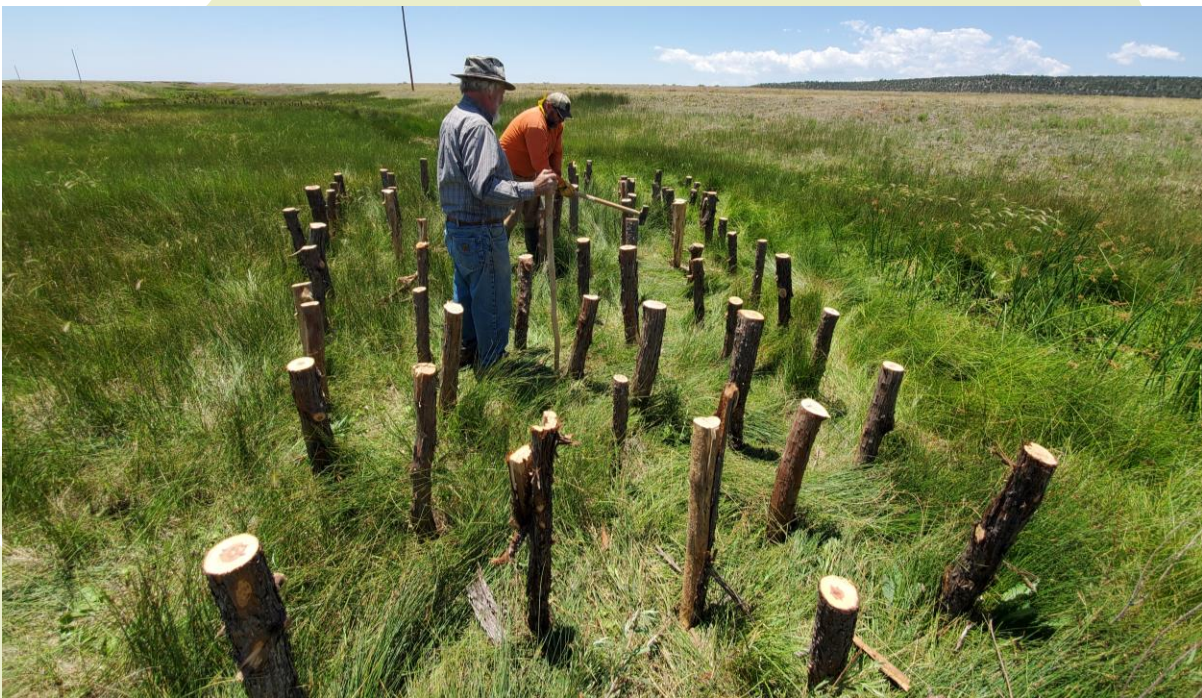
Figure 8. Bill Zeedyk directing the height of the baffle pole as well as the spacing and angle of the structure.

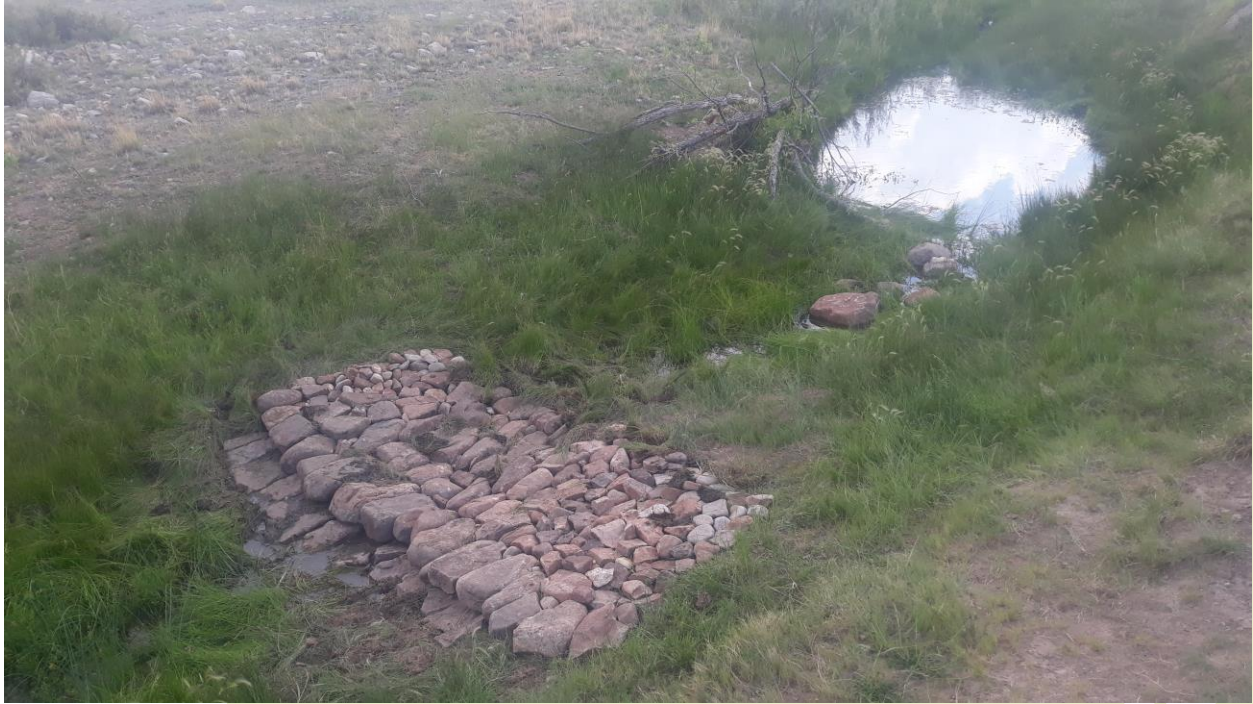
Figure 9. One Rock Dam structure built across the width of the bankfull channel on Wolf Creek.

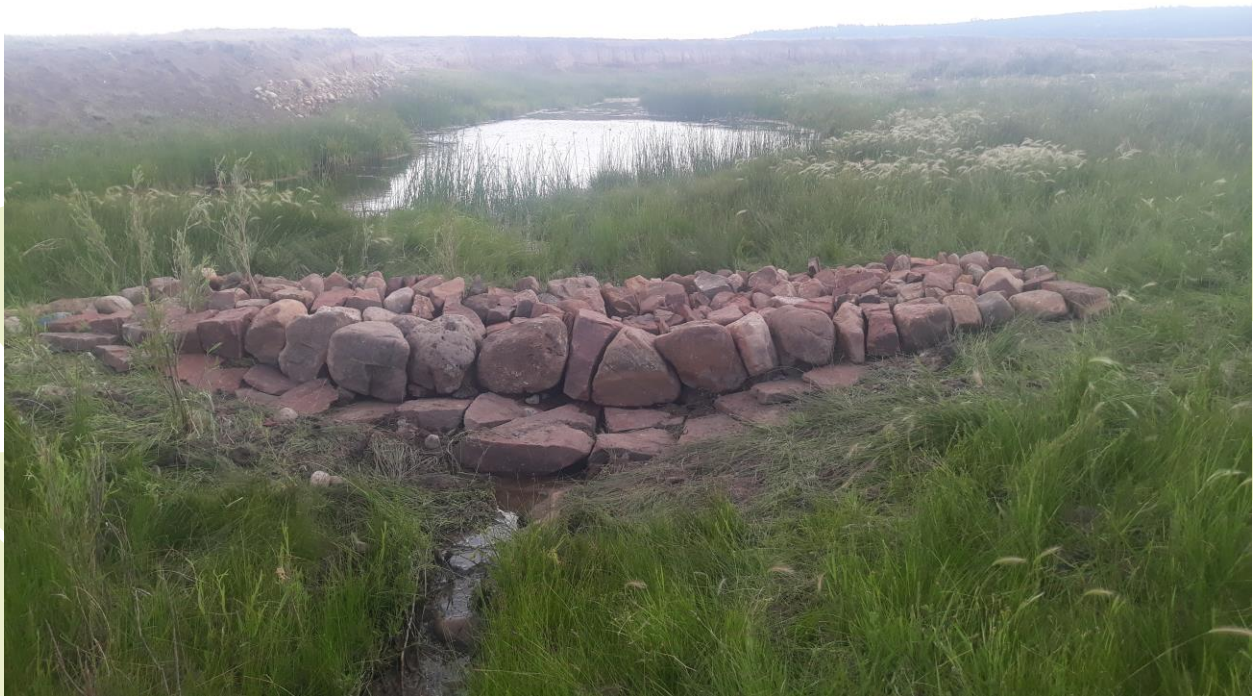
Figure 10. ORD structure from the cross section view, to show the height and width of the ORD.

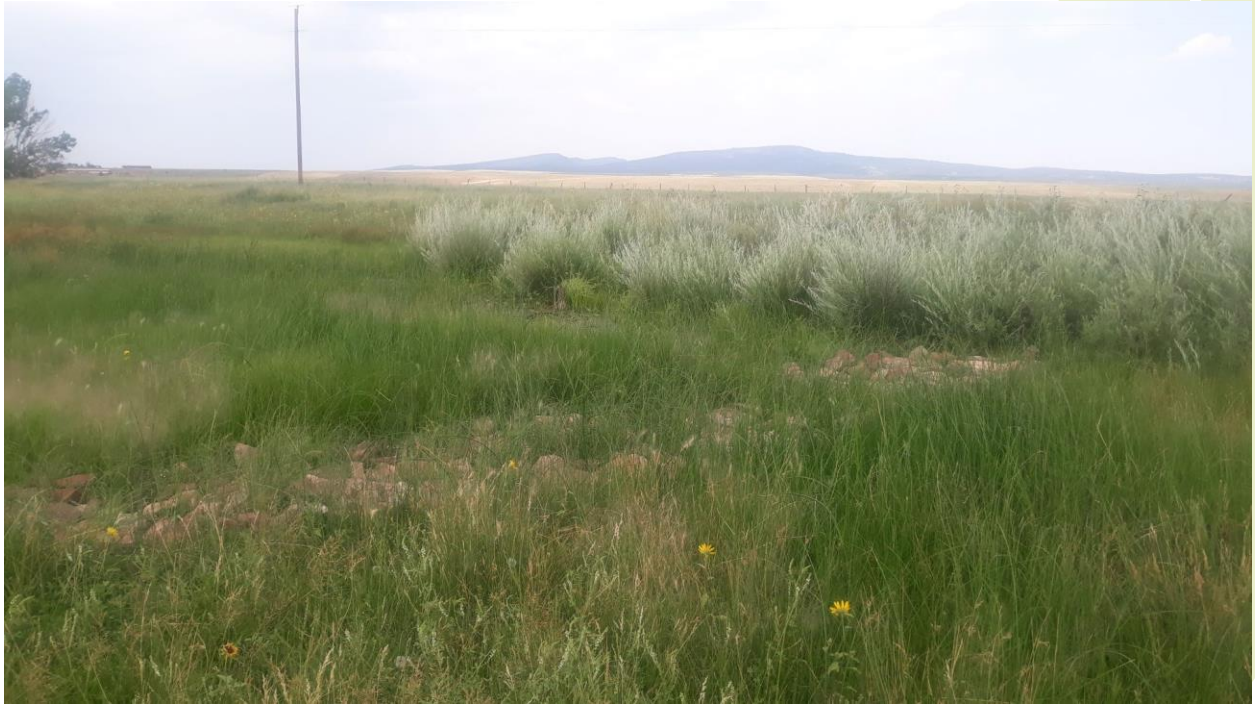
Figure 11. ORD after three months of riparian wetland vegetation growth.

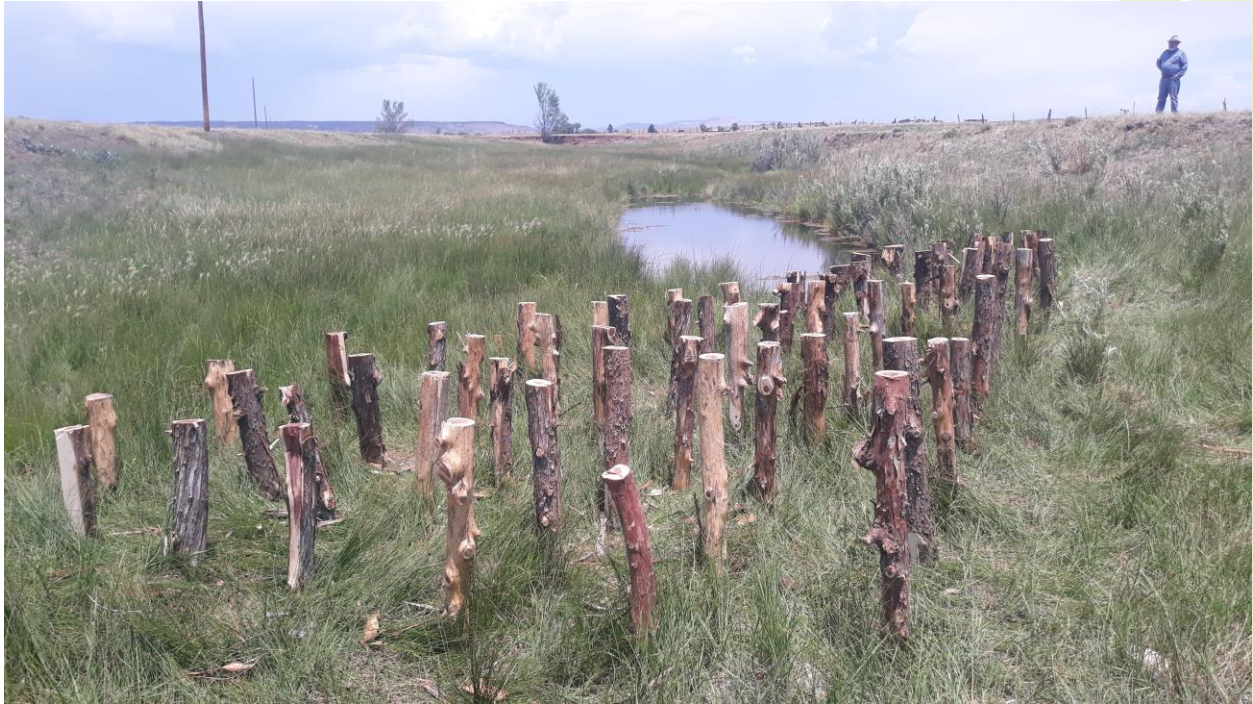
Figure 12. Baffle structure to induce bankfull flows to erode the meandering bank and increase length.

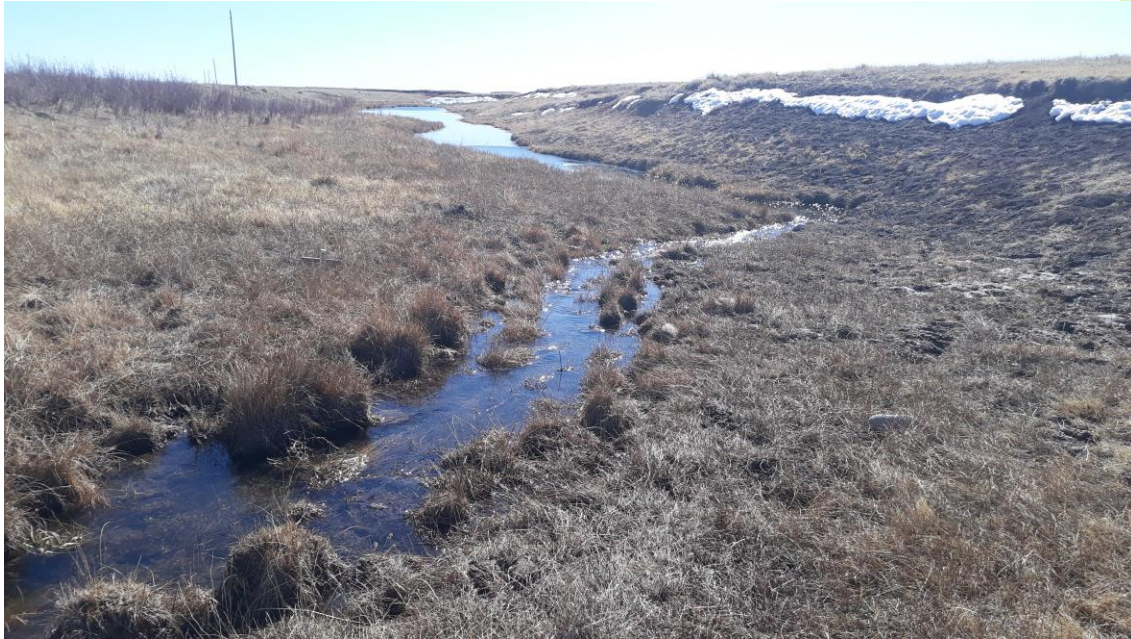
Figure 13. Site for a baffle to be constructed, prior to project implementation.

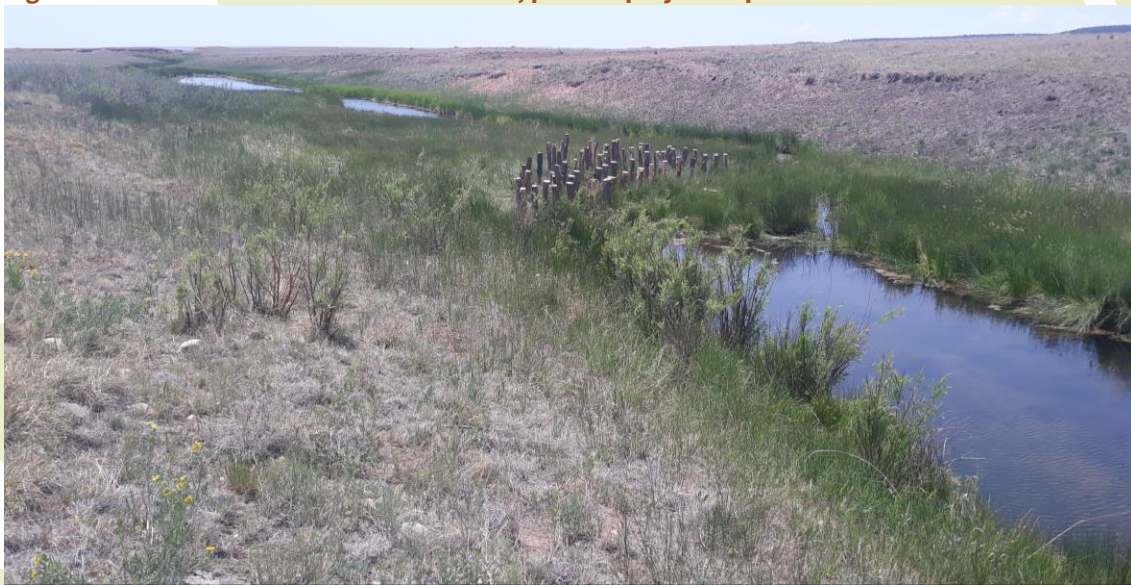
Figure 8. Constructed baffle, post project implementation.

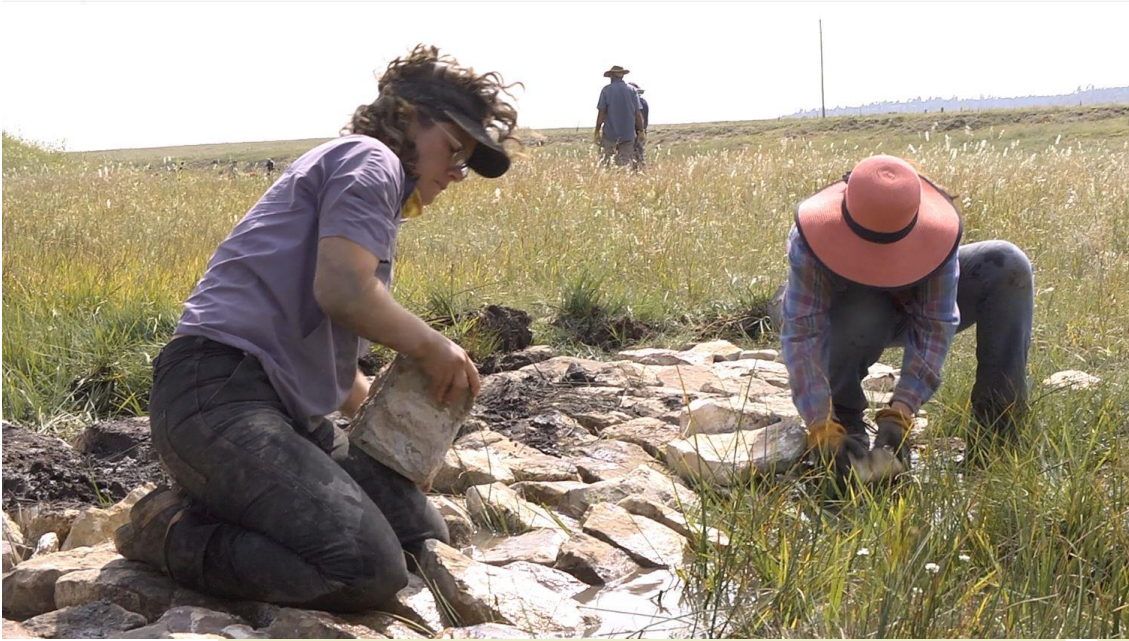
Figure 9. AWF volunteers constructing ORD structures across the bankfull width of the active channel.

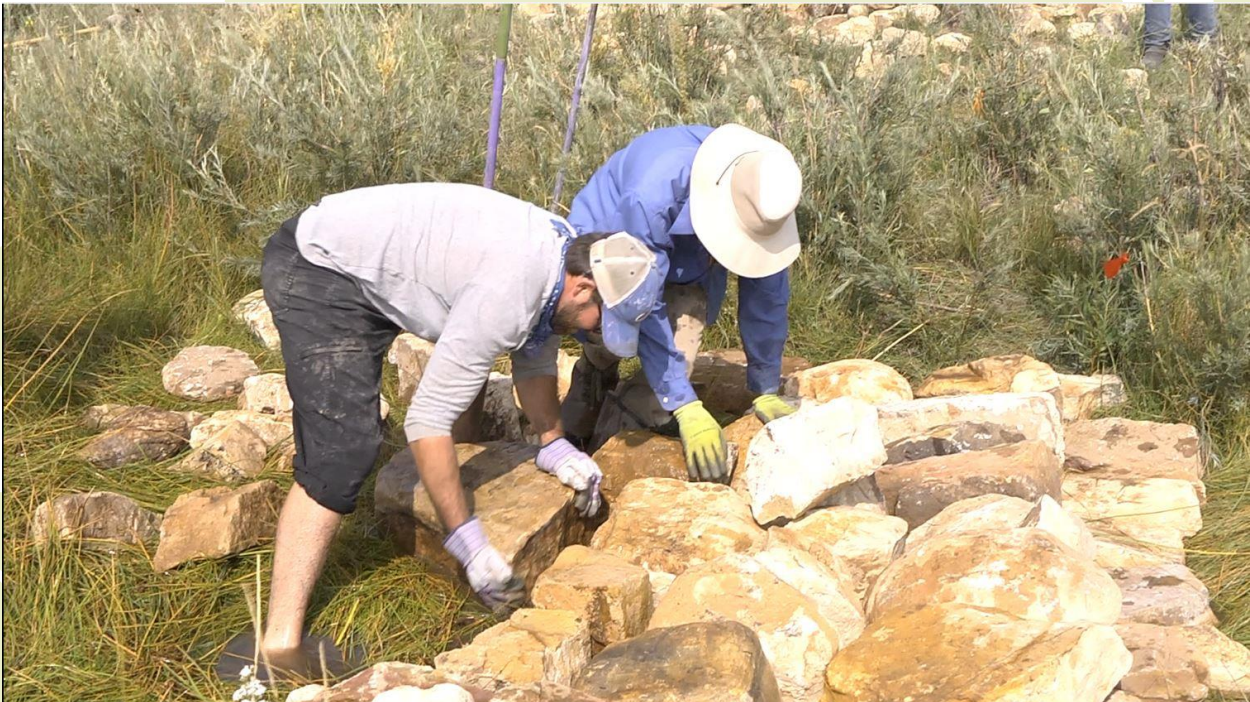
Figure 10. AWF volunteers constructing ORD structures one rock high across the active channel.

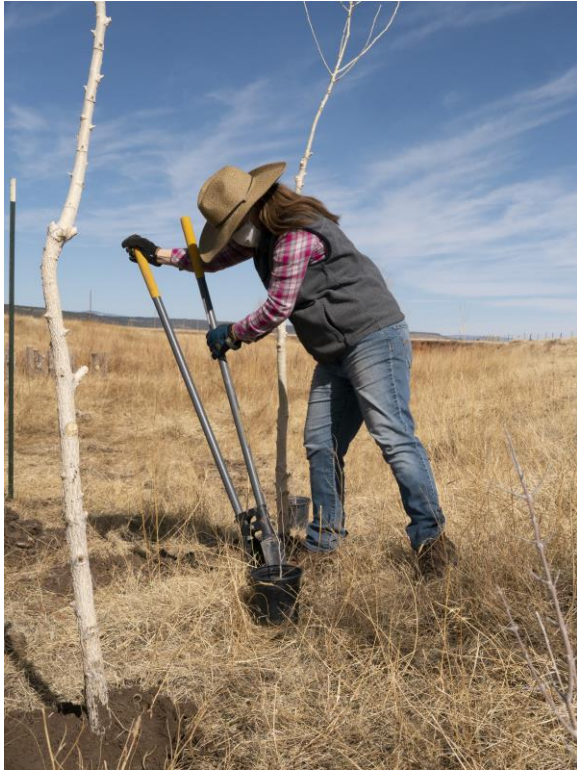
Figure 12. Amina Sena, member of HPWA, digging the cottonwood poles deep enough to hit the groundwater supplies of nearby Wolf Creek.

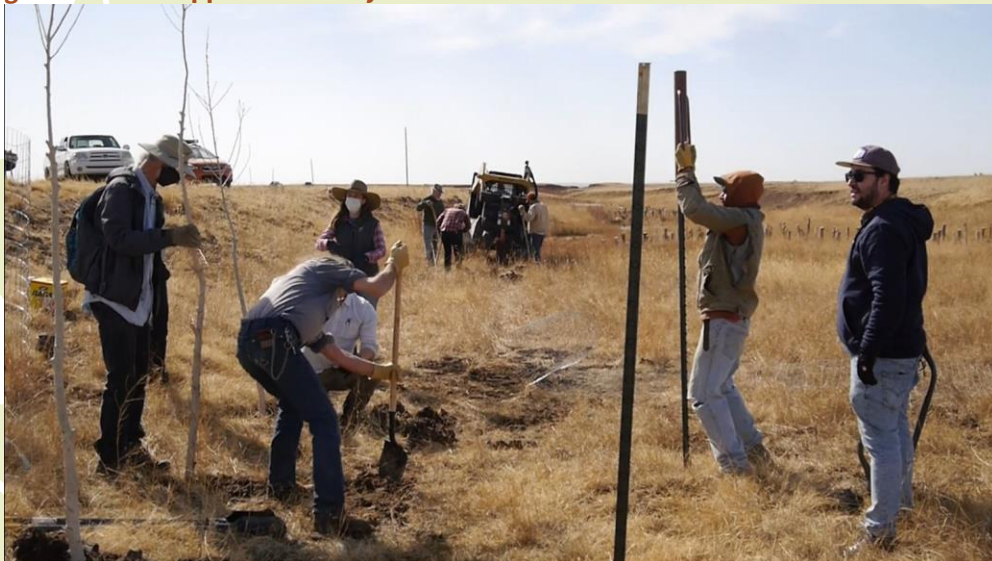
Figure 20. Volunteers from New Mexico Highlands University, helping construct small exclosure fences to promote successful regeneration of plated woody and herbaceous riparian species.

Wire cages were built with 12.5 gauge welded wire 6' tall with a 2x4" mesh obtained by Blain's Farm and Fleet. Cages were constructed approximately 3 feet away from trees and shrubs and were held by about 4 or more 8' t-posts and the wire was secured to the ground with 18" pieces of 3/8" rebar with a hook bent on one end.

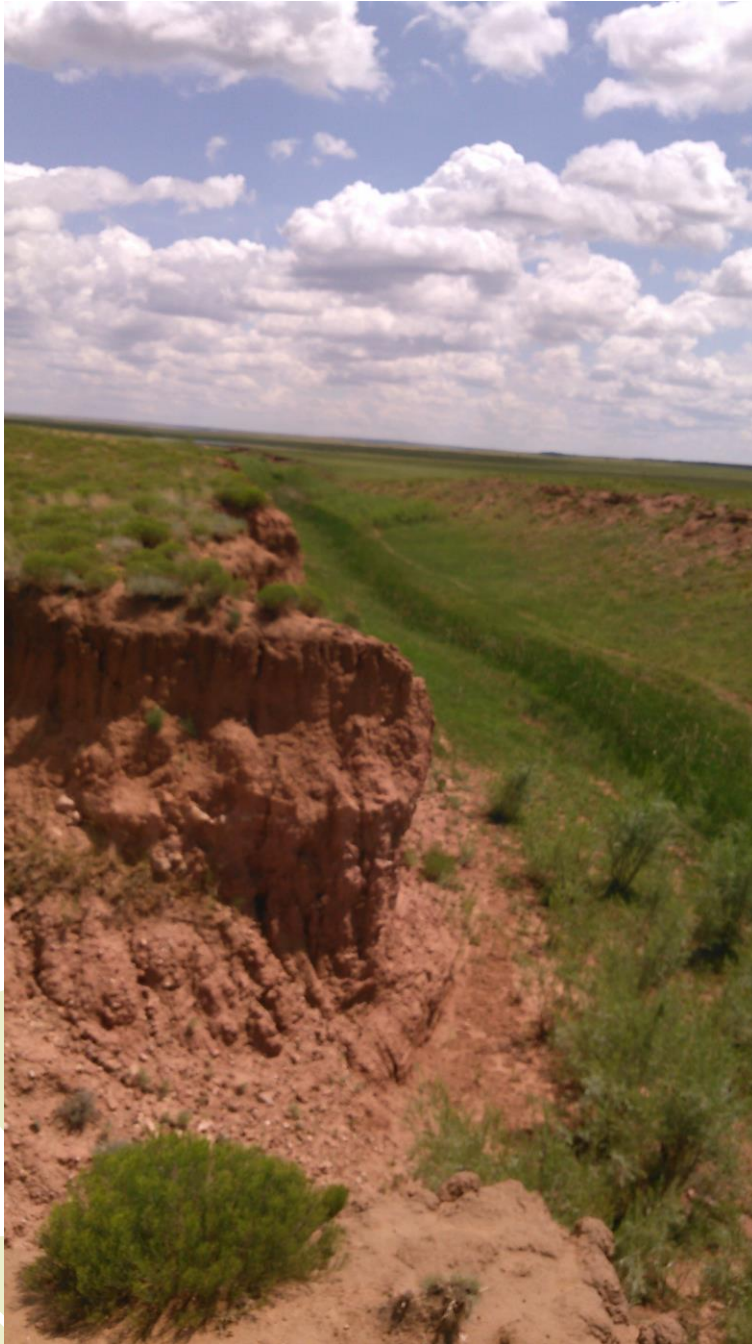
Figure 21. Constructed inlet to Wheeler Lake that diverts all Wolf Creek flows in this straight channel.

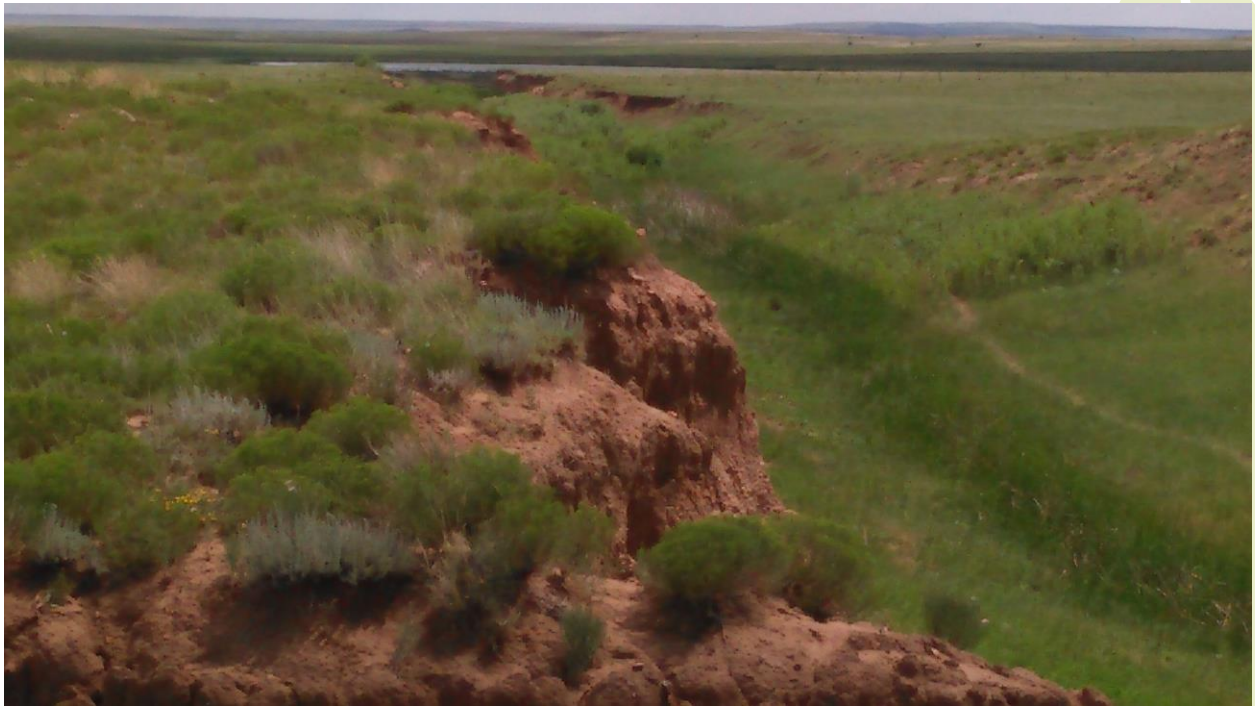
Figure 22. Wheeler Lake full of water in the background of the constructed inlet channel.

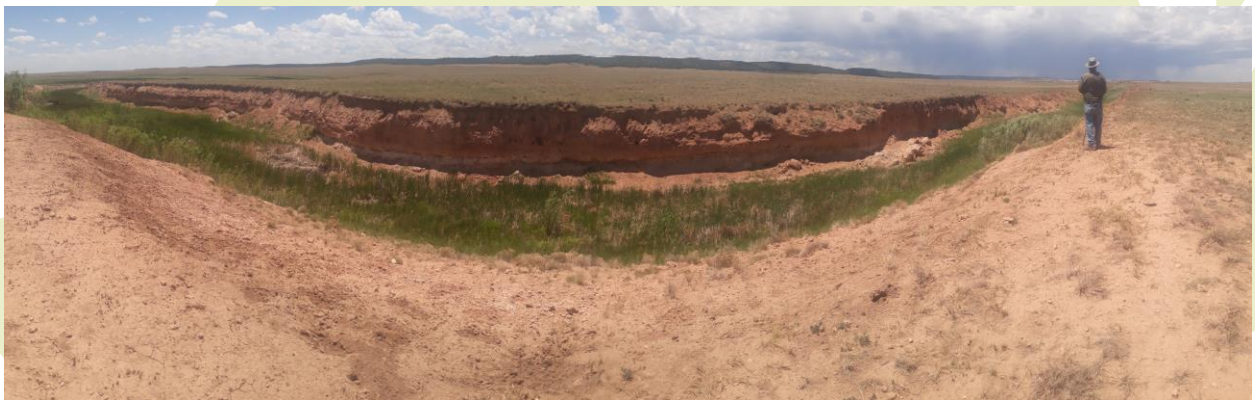
Figure 23. Bill Zeedyk assessing for future restoration treatments surrounding Wheeler Lake and the inlet and outlet channel that currently diverts all of Wolf Creek.
